GIANT FOREST  
**SEQUOIA**

**A Historical and Architectural Study of  
Three Rustic Structures at Giant Forest in Sequoia National Park  
The Market, District Ranger's Residence, and Comfort Station**

**HISTORIC STRUCTURES REPORT  
SEQUOIA NATIONAL PARK**

Approved  
December 7, 1988

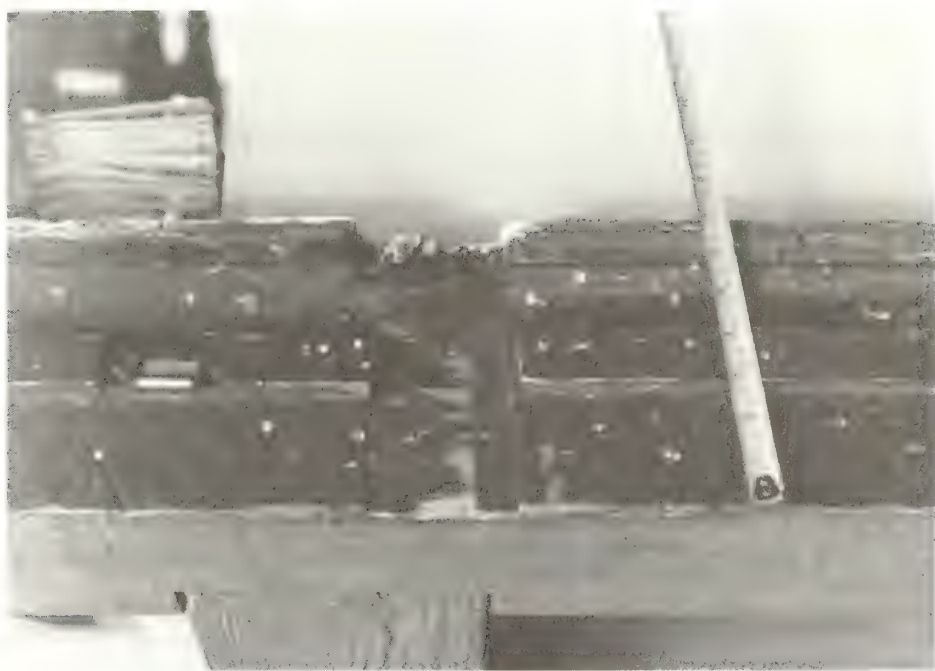
Figure 81 (left). Market Door (10/86). Most of the market doors were bi-fold, center hinged. This door--to room 100--is the only unmodified bi-fold door remaining. It is inoperative because asphalt has been placed at its sill to control water run-off. The negative effect of the asphalt is that it traps moisture against the door causing it to rot. This asphalt walk also buries a crawl space vent window to the left of the door (not visible). The asphalt should be removed and the site grade lowered. Door repairs may involve replacement of excessively rotted members, filling holes and refinishing. Door hardware should be cleaned, repaired, duplicate replacement parts installed and historically finished.

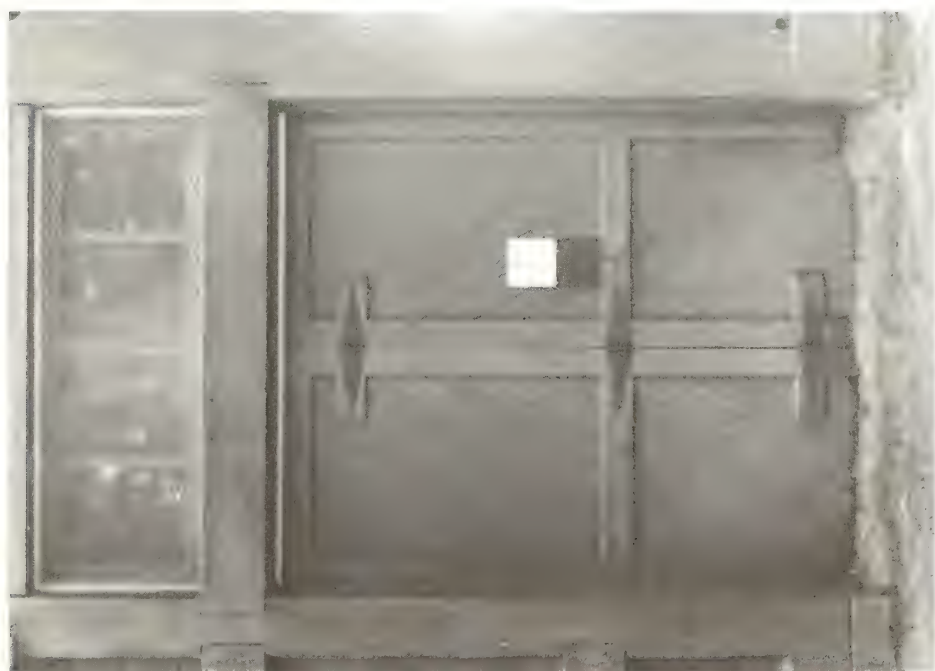
Figure 82 (right). Market Door Jamb (10/86). This detail of an exterior door jamb to room 102 show the history of doorway modifications common to the market: door swings have been reversed and locking and latching systems have been changed. This detail shows that doors are fitted directly to the timber framing--a separate casing is not employed. Notice that the 3/8" x 11-3/4" vertical interior paneling is placed directly over the horizontal shiplap exterior skin of the building. There is a need for insulation and vapor barrier between and for a fire-resistive upgrade of the wall.

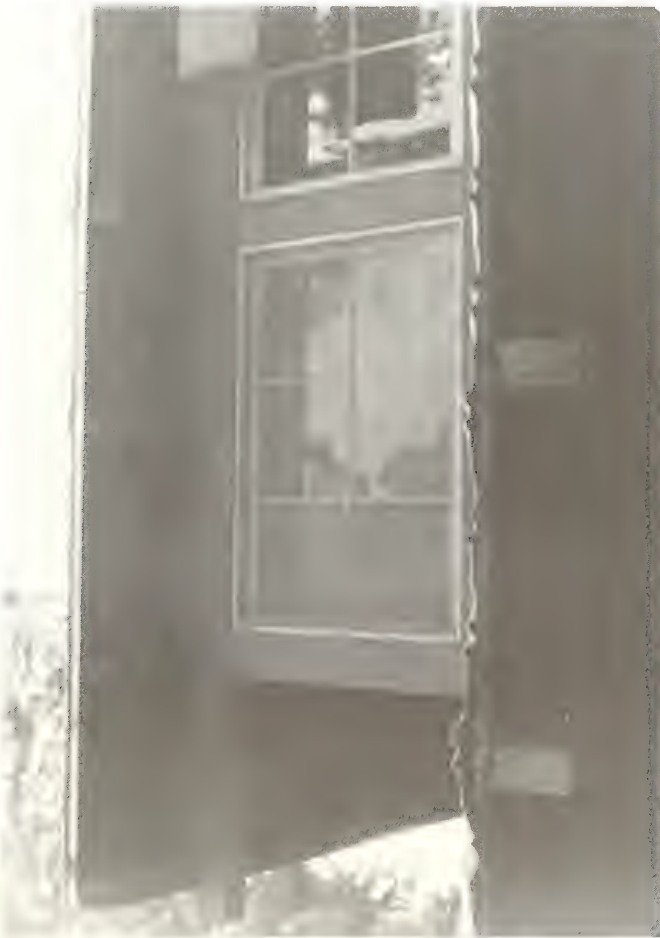
Figure 84 (right). Market Addition Window (5/86). Most of the additions' windows are 'permanently' covered with plywood and boards. This seems to be a defense against vandals and snow/moisture damage. This practice may be trapping moisture and accelerating damage. Many windows have missing or broken hardware. This window is weatherstripped tight and nailed shut and covered with plywood on the exterior. Window repairs should include refinishing sashes, reglazing where necessary and renewal of hardware including adequate security locks.

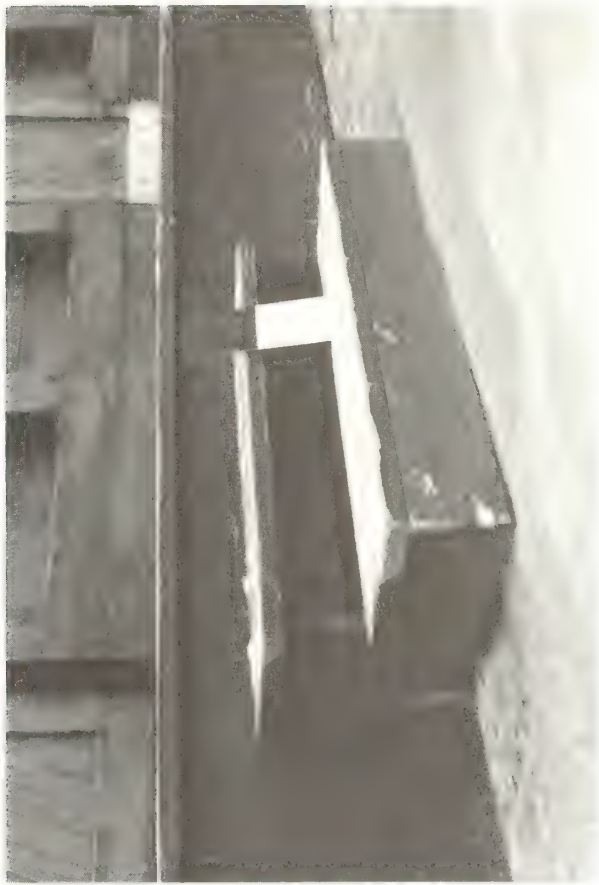
Figure 85 (left). Market Accessibility (10/86). The door sill here is about 18 inches above the walkway. This door would permit entry to room 101, but is not in use. A sizable ramping network would be necessary to make all market doors wheelchair accessible. Notice, too, mismatched door hardware.

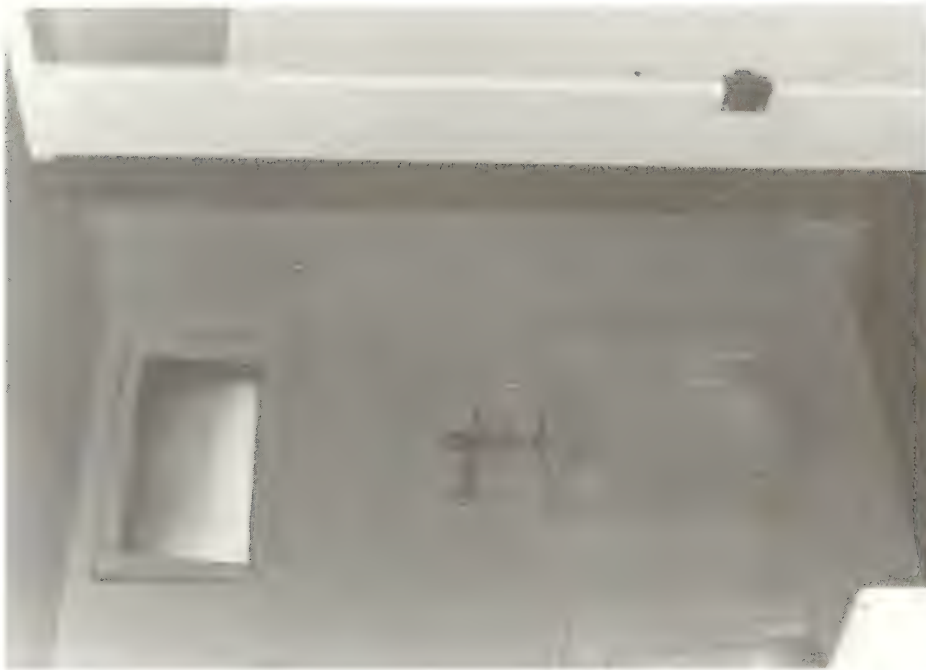
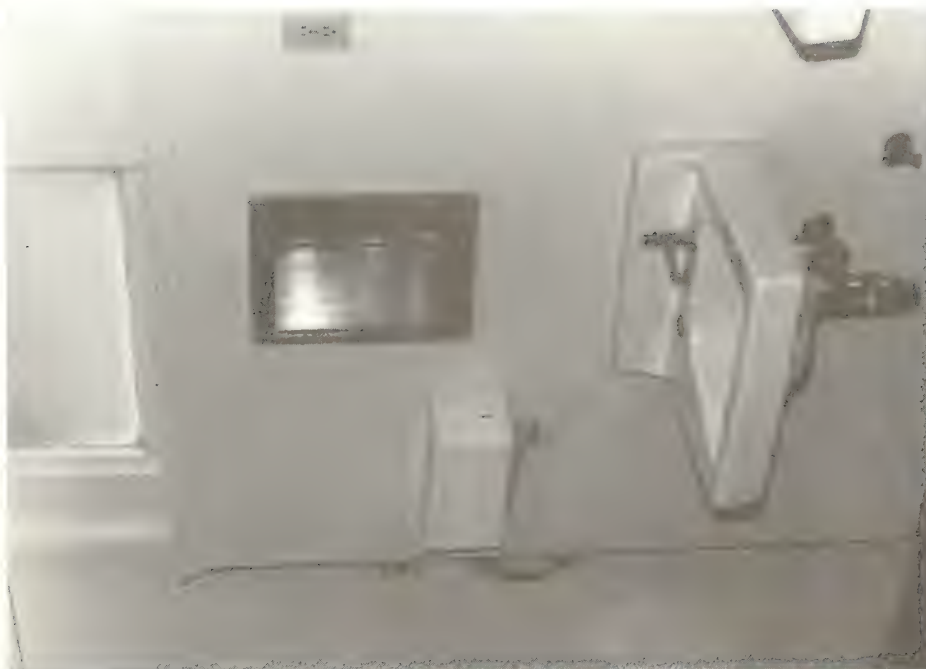
Figure 93. Comfort Station, Men's Room (5/86). These views show the interior character as a result of the 1964 rehabilitation. Notice only cold water is provided at the lavatory, the steel toilet stall partition is intrusive, and window glazing is mis-matching. Not visible is paint buildup on formica wall paneling which is no longer easily cleaned. Also notice A/C outlet which is not fitted with a GFCI. These deficiencies should be corrected as part of a comprehensive and historically sensitive rehabilitation design.

13) doors are aged and damaged	13) normal use	
14) lack of uniform window glazing (see figures 66, 93, and 94)	14) variety of window glazing patterns exist due to replacements at different times with non-matching glass

17) electrical wiring outlets and fixtures are old but not original; and are historically incompatible and insufficient (see figures 93 and 94)	17) same as #16; National Electrical Code requires GFCI outlets in restrooms; fluorescent lighting is inappropriate in this historic structure

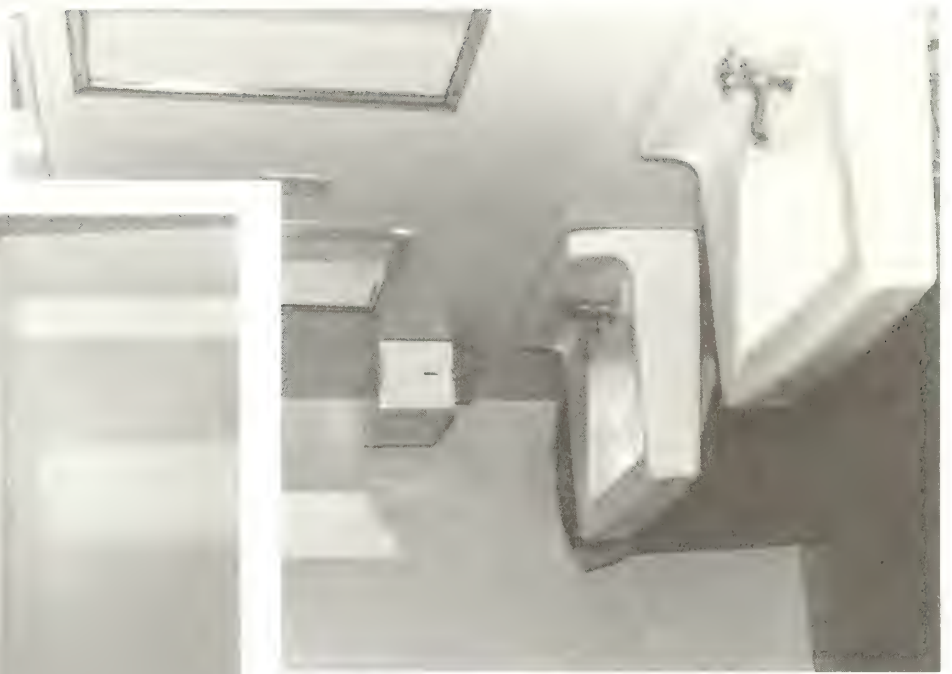
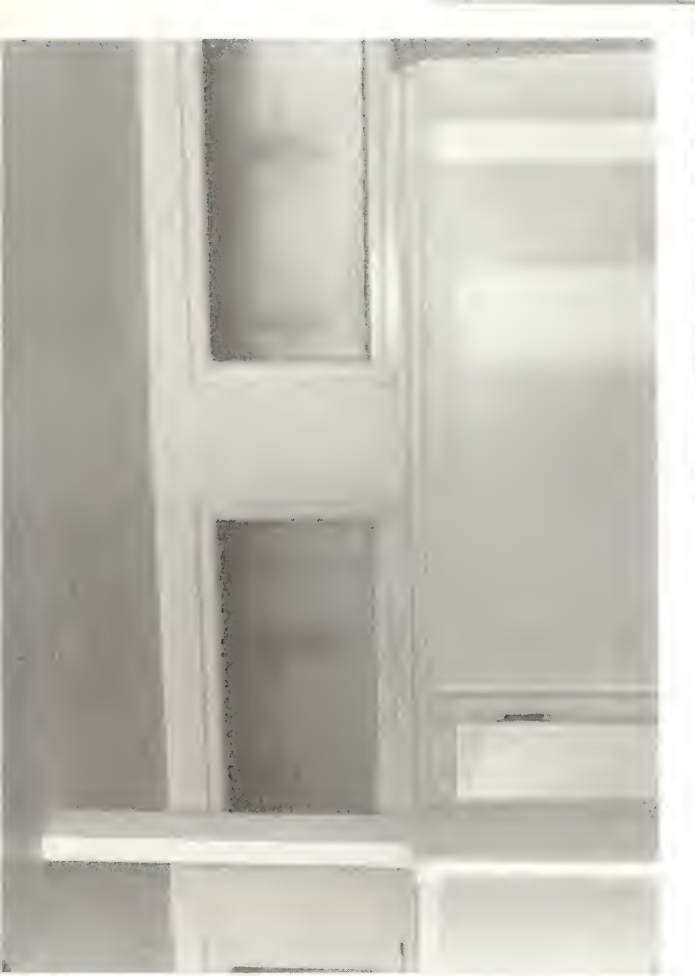
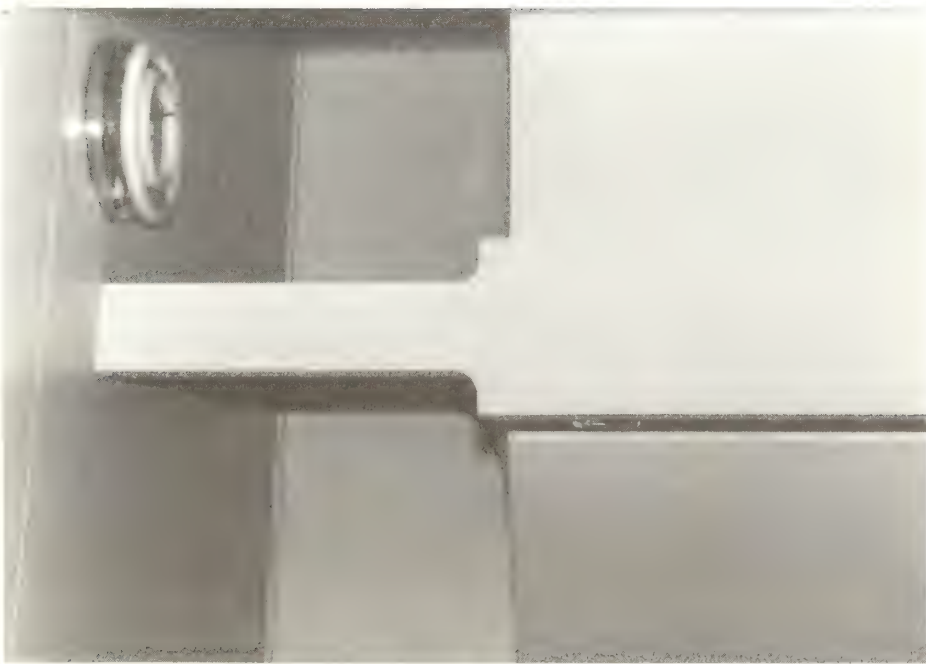
Figure 94. Comfort Station, Women's Room (5/86). These views include wooden toilet stalls which 'fit' the character somewhat better than those in the men's room. Notice fluorescent ceiling fixture, non-matching lavatory taps, non-matching glazing and A/C outlet without GFCI. The walls, ceiling, windows and doors are below standards of energy conservation. Materials do not meet fire resistive standards. Rehabilitation should correct these deficiencies.

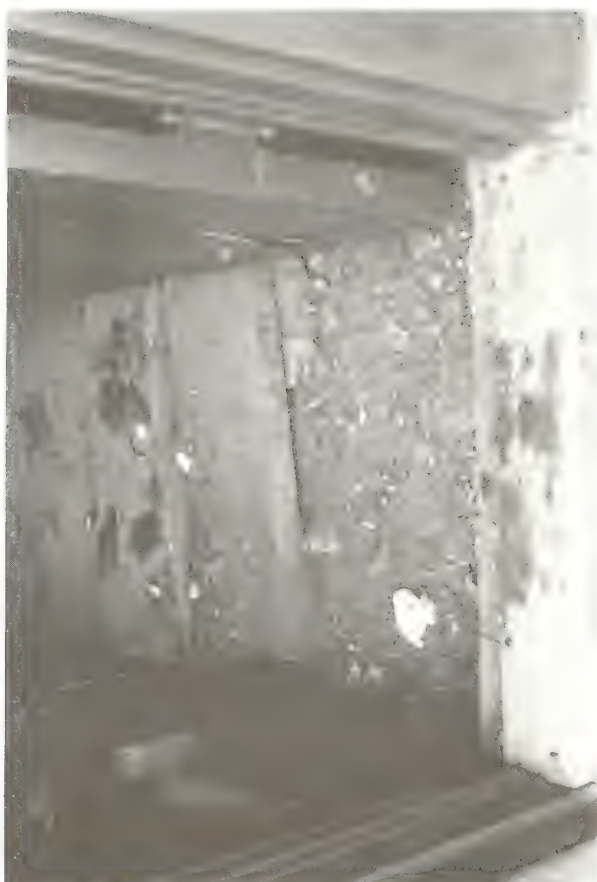
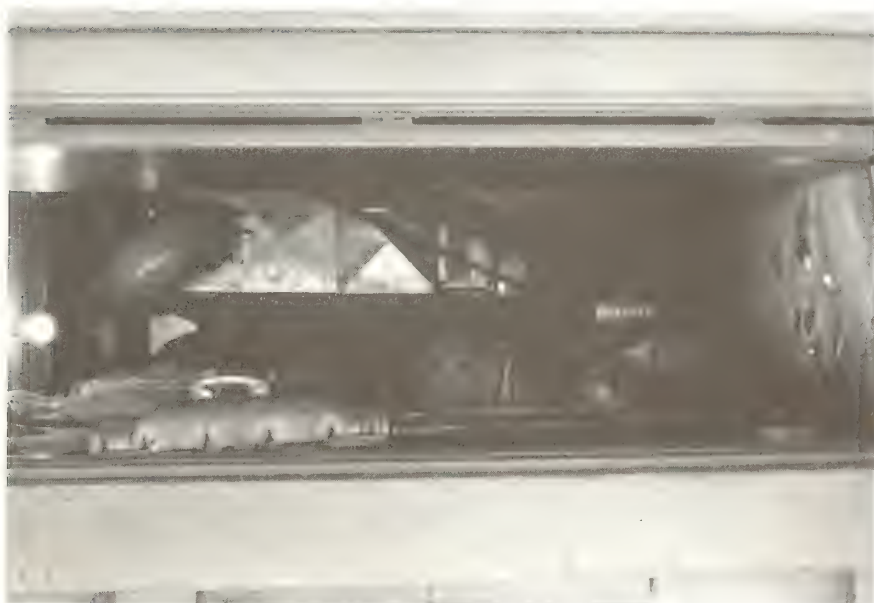
Figure 95. Comfort Station, Room 101 (5/86). These views are taken from the east side of the comfort station through the door into the utility chase which separates the men's and women's rooms. The electric furnace is fairly new (ca. 1983) and adequate but its flexible ducting is damaged. This should be resecured or replaced with more durable material. The entire left hand wall is cluttered with telephone switching equipment and panel board. These should be eliminated when the service needs are removed when Giant Forest development is moved elsewhere. The makeshift floor is unsatisfactory and should be stabilized. Barely visible in the view at left is the T&G ceiling paneling which probably exists under the formica finish in both restrooms. Some T&G should be saved and reused in the rehabilitation in all comfort station rooms on the ceiling for example.

11) no floor planking at entry inside service area (mechanical space, room 101, see figure 95)	11) finish floor is absent at door

The comfort station foundation, walls, and roof structure were all found to be in good condition (see figure 95). The structure and significant elements are intact, structurally sound, and performing their intended purpose. Calculations show the roof is capable of supporting an allowable total load of approximately 210 psf (see figure B-9, sheet 7-9). Reduction of snow load by shoveling has never been performed at this building according to the park staff. The total load capacity of 210 psf appears to be an adequate design load.

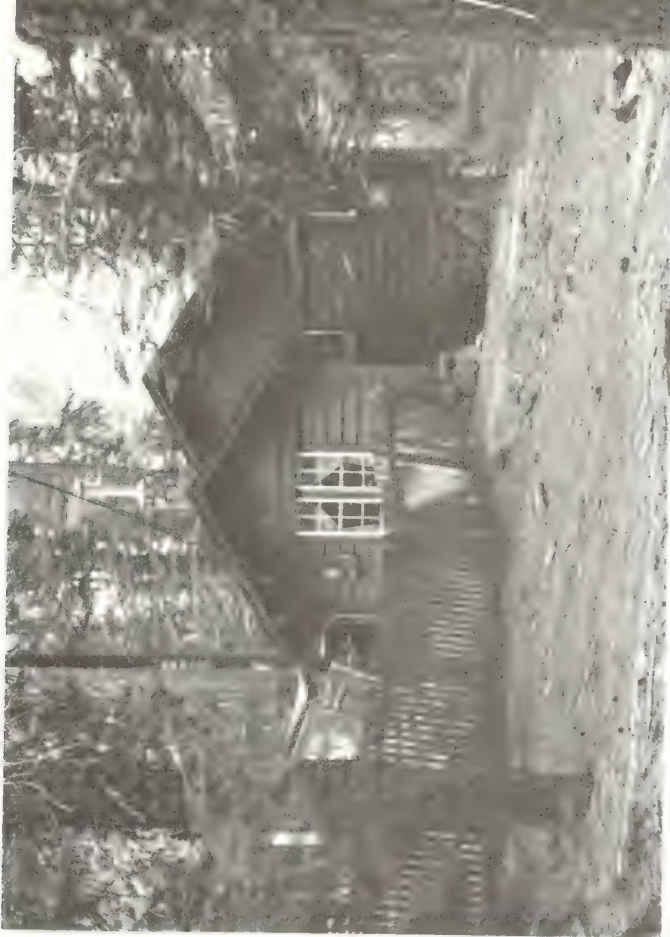
Figure 96 (left). Ranger Residence, View from West (5/86). Spot repointing of the stone chimney and foundation are recommended. The stone retaining wall at right is partially collapsed allowing negative site drainage patterns. The wall should be rebuilt. The crawl space vent window is partially buried by earth buildup. Several areas of site grading are suggested. Notice intrusive communication antennae blocking windows.

4) mortar voids in chimney and foundation	4) same as #1; poor original pointing	
5) crawl space access door and vent screen have deteriorated (see figure 96 and 97)	5) same as #1

Deficiency	Cause/Notes	Treatment
<u>Site Work and Landscape</u>		
6) negative surface water drainage towards house (see figure 96)	6) from hillside and build-up of natural fill	rebuild stone retaining wall and regrade immediate site to achieve positive surface water drainage; repair or replace gate and fence
7) natural debris build-up along west and south foundation (see figure 96)	7) historic stone retaining wall has collapsed	wooden elements and/or hardware; restore walk by removing soil build-up
8) gate loose at hinges and fence deteriorated (see figure 97)	8) same as #1	
9) walk has deteriorated (see figure 69)	9) same as #1, soil erosion

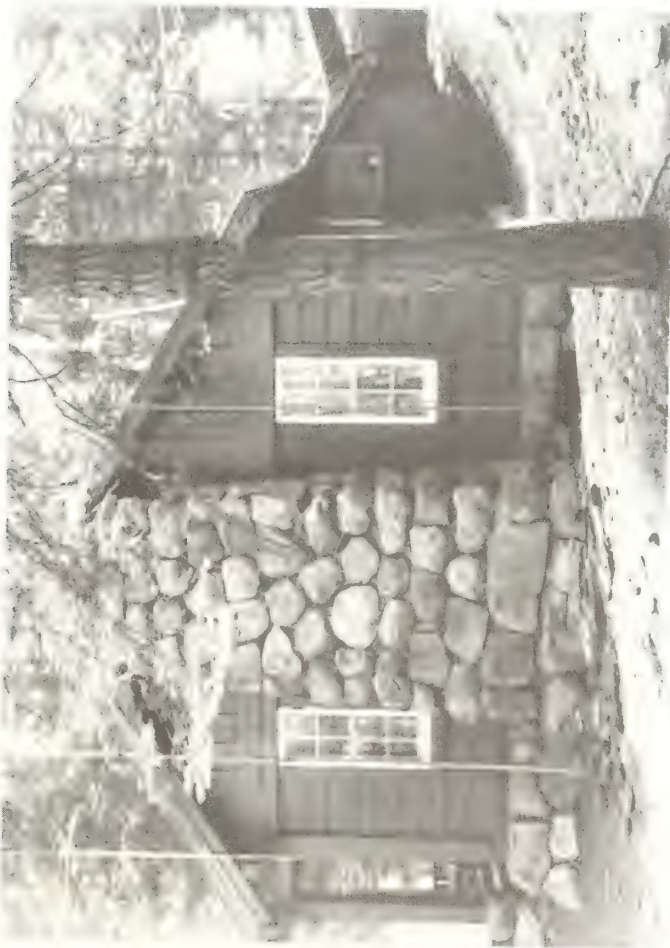
Figure 97 (right). Ranger Residence, View from East (10/86). Some repairs are recommended to stabilize the fence and gate. The crawl space access door is broken and should be repaired. The building needs repainting and reroofing.

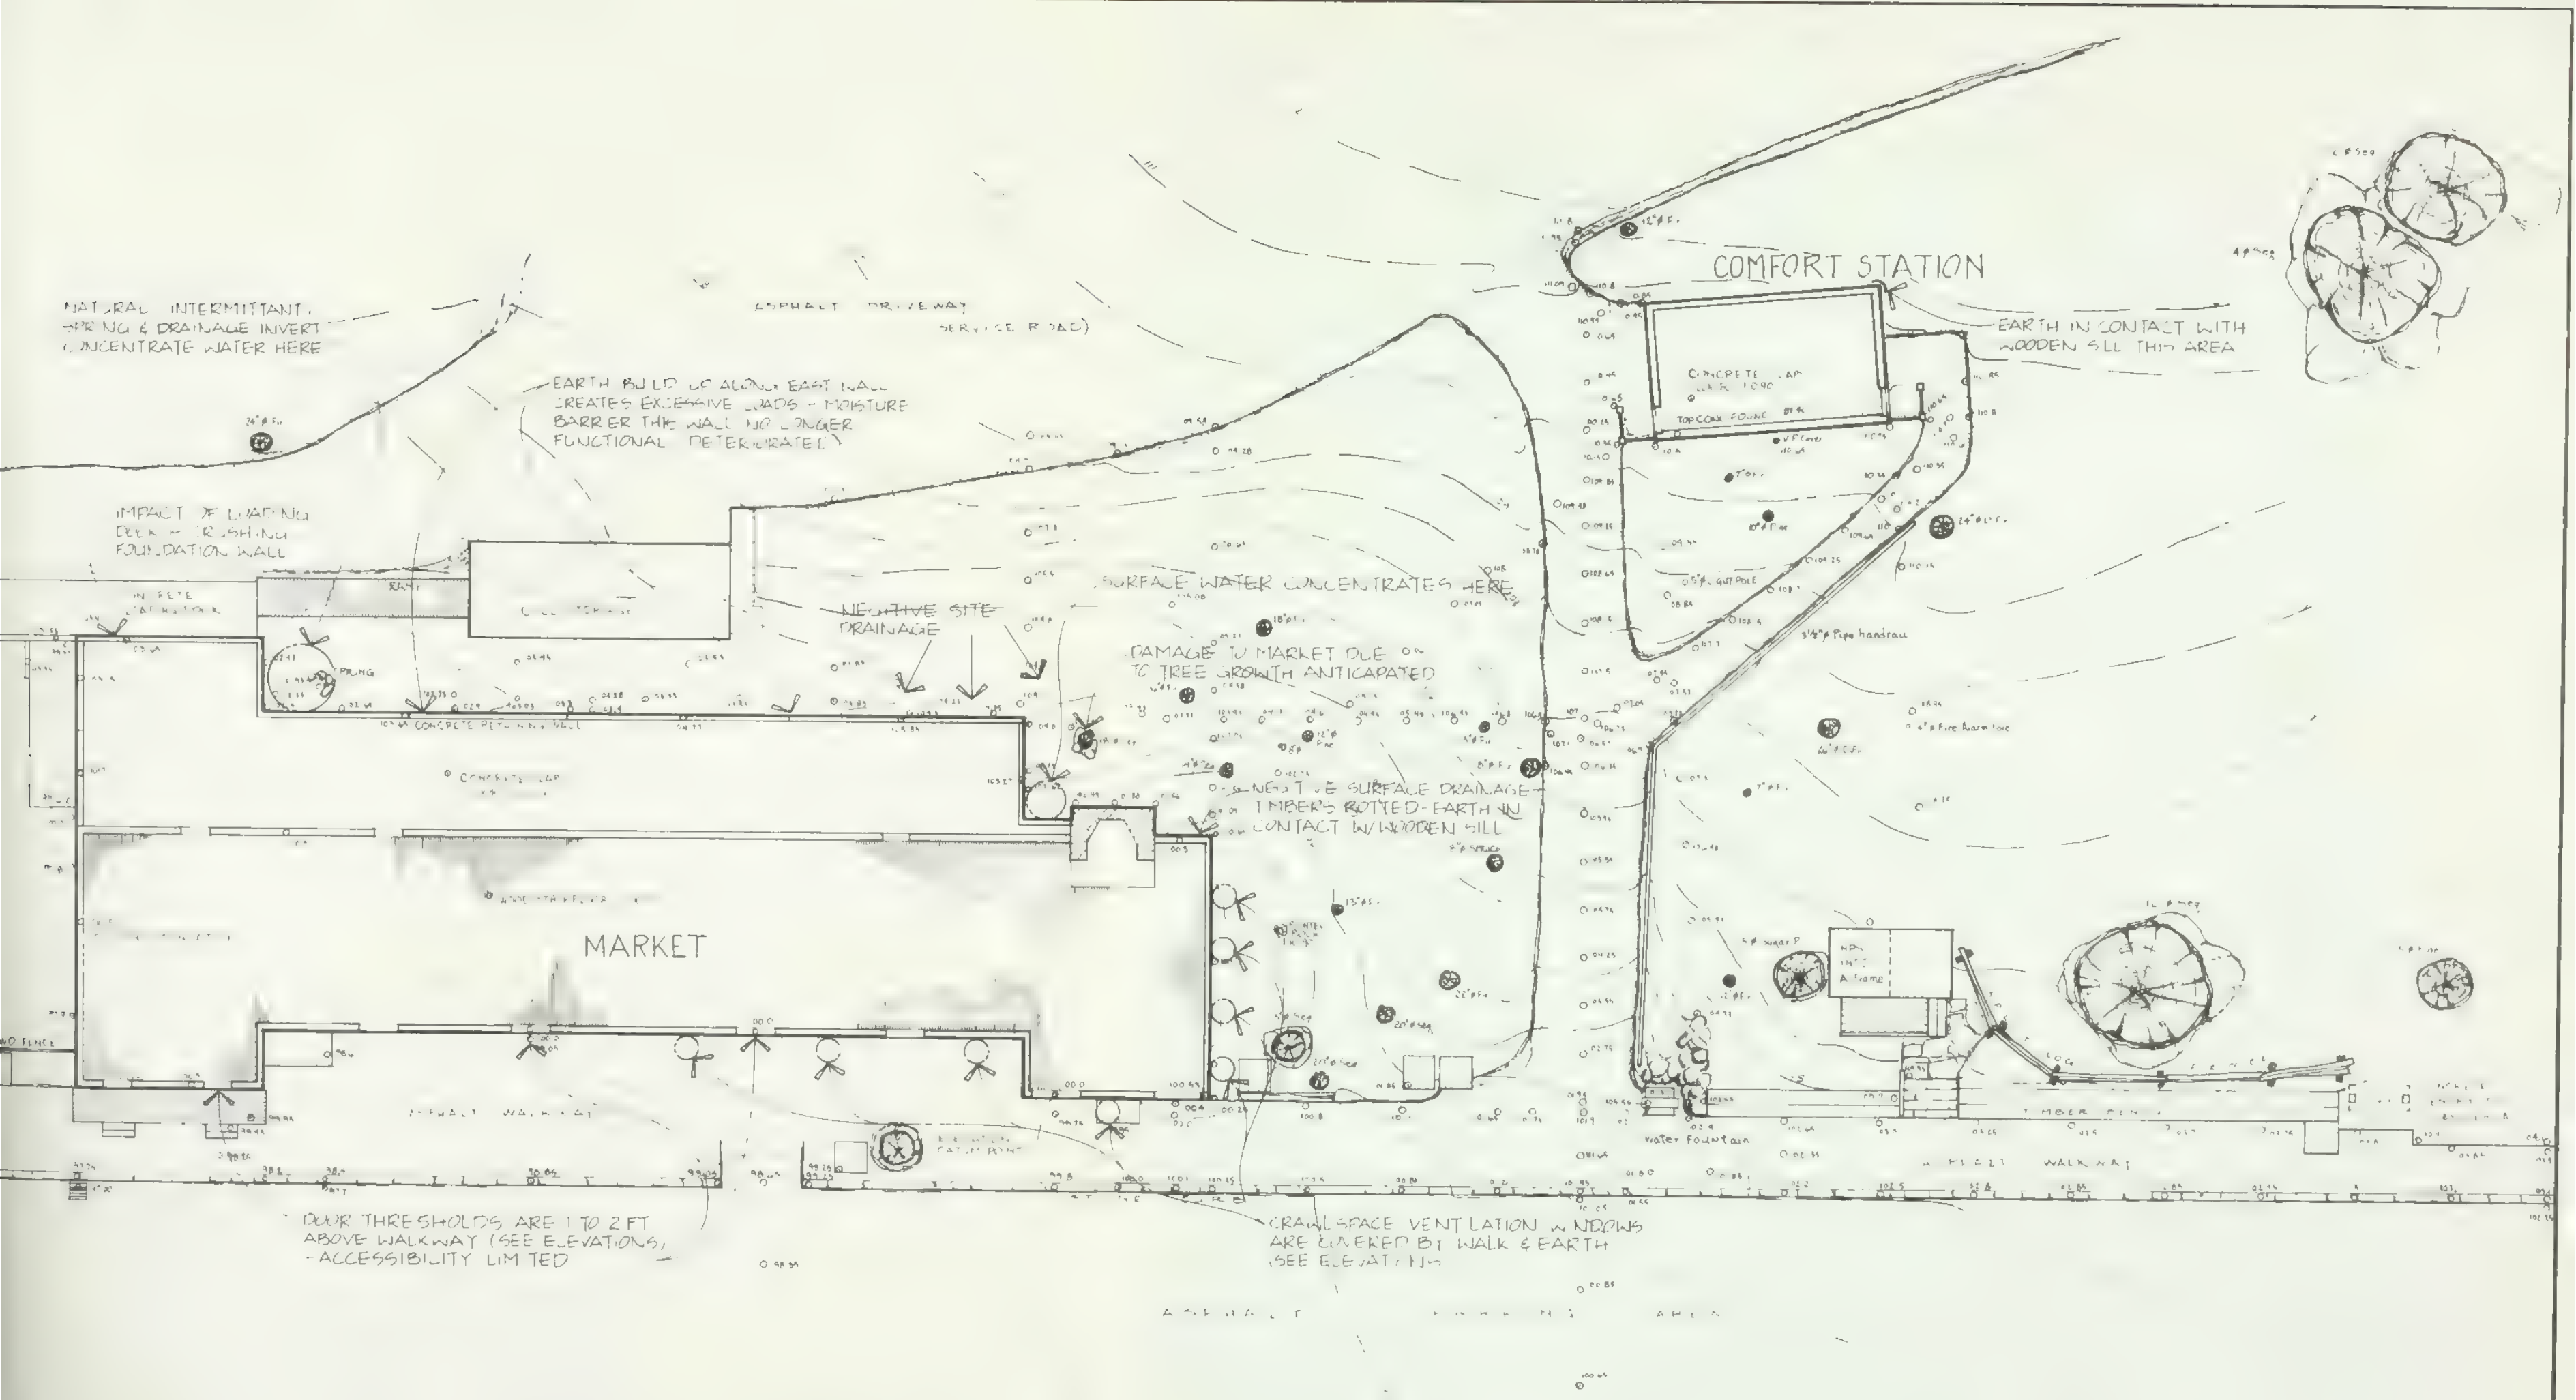
OUR THRESHOLDS ARE 1 TO 2 FT ABOVE WALKWAY (SEE ELEVATIONS) - ACCESSIBILITY LIMITED

CRAWLSPACE VENTILATION IN ROWS ARE COVERED BY WALK & EARTH (SEE ELEVATIONS)

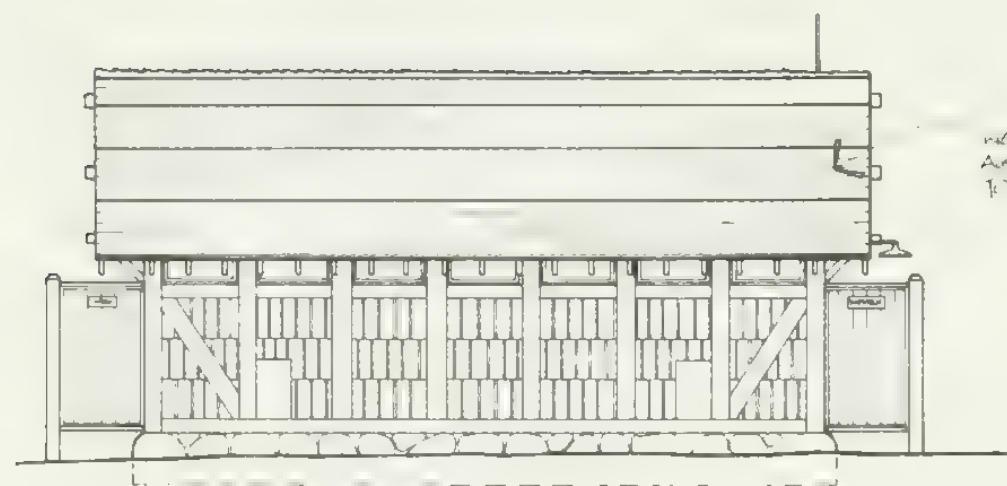
WEST

WOOD SHINGLE ROOF IS  
AGED AND EXPECTED  
TO FAIL BY 1995

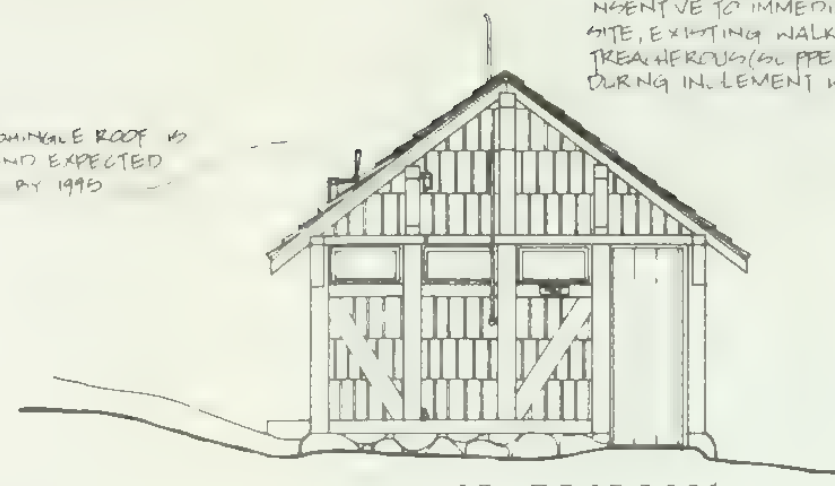
NORTH

SERVICE ROAD IS  
NEARBY TO IMMEDIATE  
SITE, EXISTING WALK BECOMES  
DANGEROUS (SLIPPERY)  
DURING INCLEMENT WEATHER

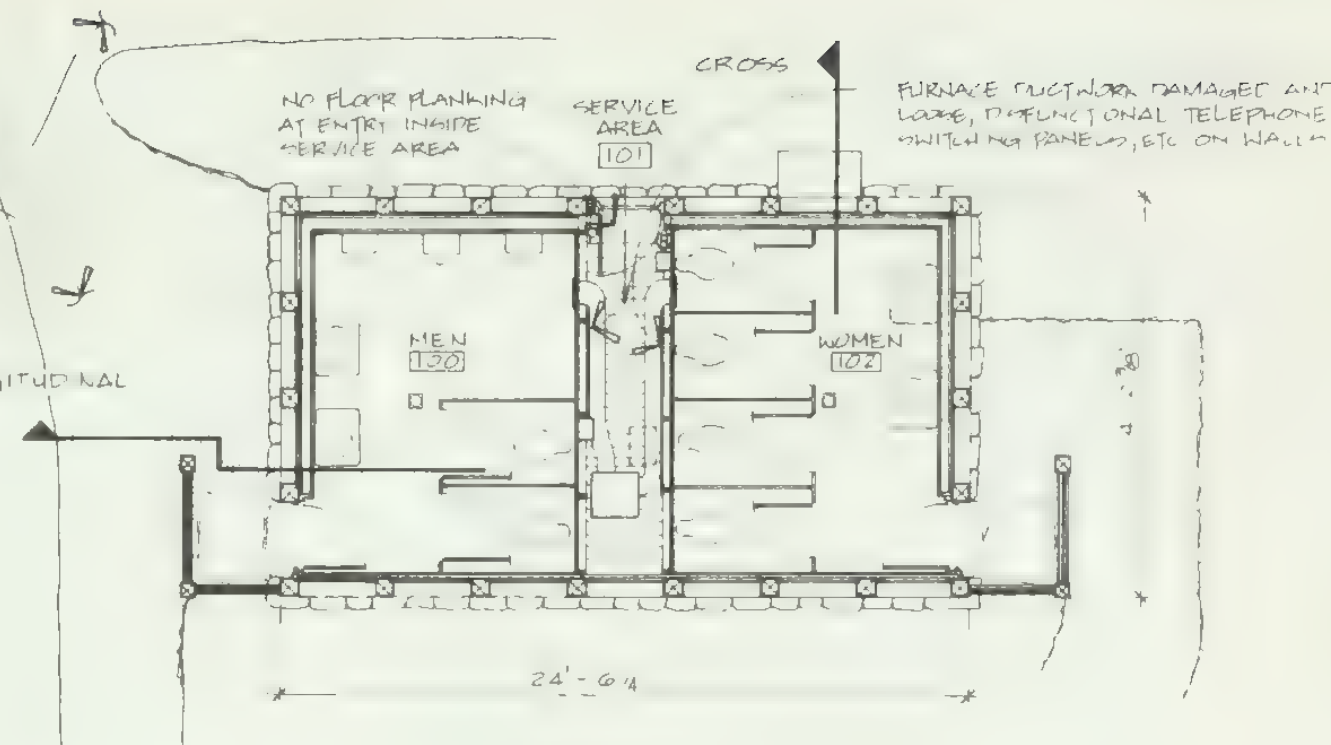
FLOOR PLAN

FURNACE FACTORY DAMAGED AND  
LOOSE, DYSFUNCTIONAL TELEPHONE  
SWITCHING PANELS, ETC ON WALL

THE BRACE IS  
NOT TIGHT  
WALL BEAM

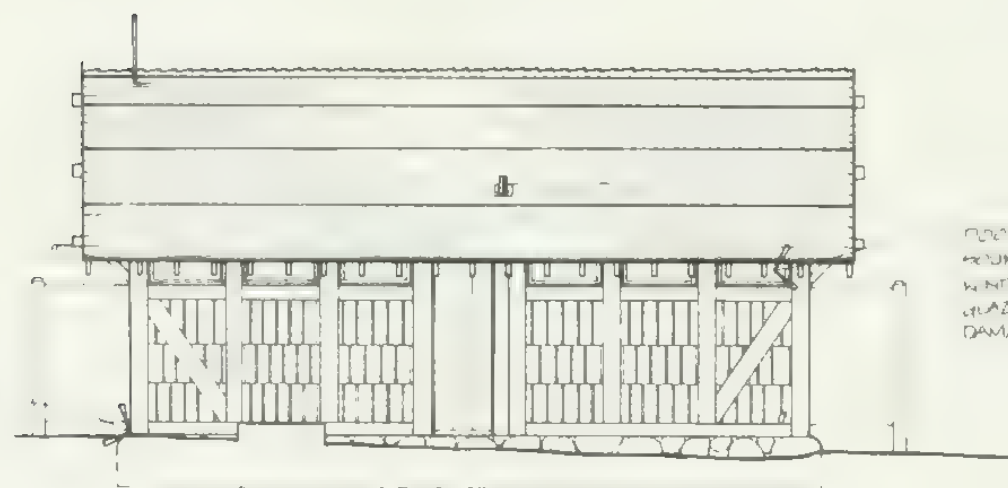
EAST

FLOORS AND WINDOWS ARE  
SOURCES OF HEAT LOSS,  
WINDOWS ARE NOT UNIFORM,  
GLAZER AND GLASS ARE  
DAMAGED

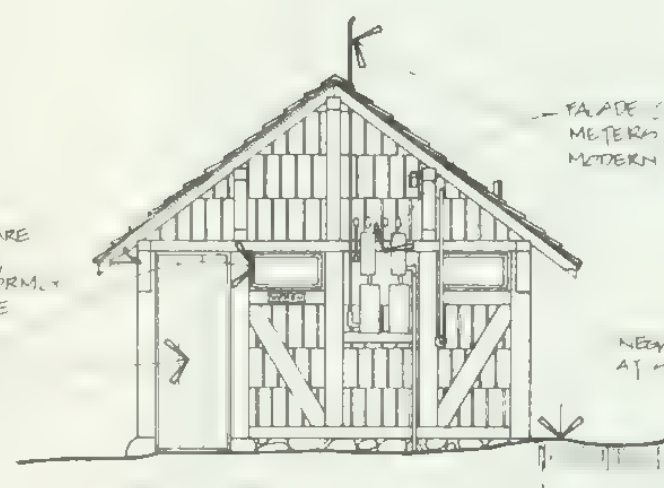
SOUTH

FACADE CLUTTERED WITH ELECTRICAL  
METERS, HOSE-UPS, MASTHEAD, ETC.  
MODERN ACCRETIONS ARE INTRUSIVE

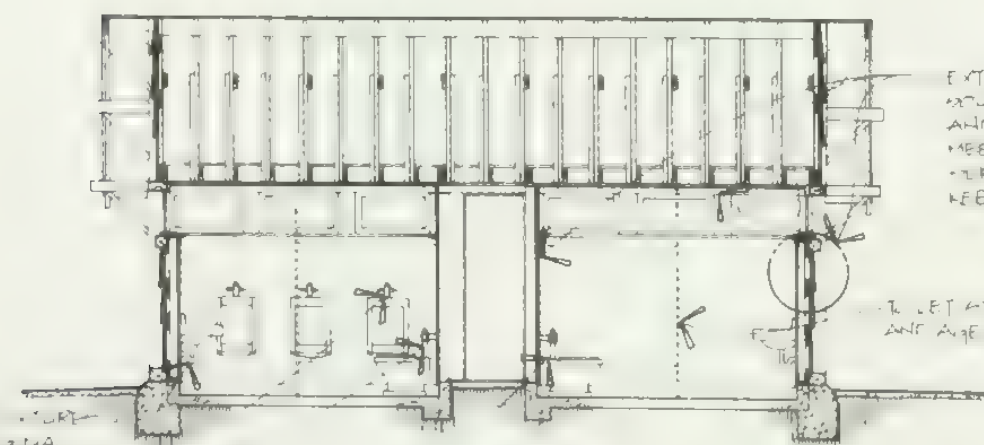
LONGITUDINAL

EXTERIOR WALLS AND ATTIC ARE  
SOURCES OF HEAT LOSS UNINSULATED  
AND WALLS AND CEILINGS DO NOT  
MEET FIRE CODES INTERIOR  
SURFACES ARE DIFFICULT TO  
KEEP CLEAN (TIMBER)

TOILET WALL PARTITIONS ARE WORN  
AND ARE NOT ORIGINAL

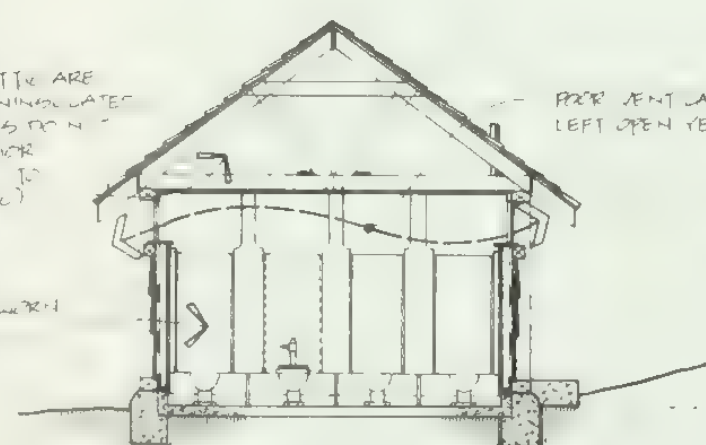
CROSS

POOR VENTILATION WINDOWS MUST BE  
LEFT OPEN YEAR ROUND

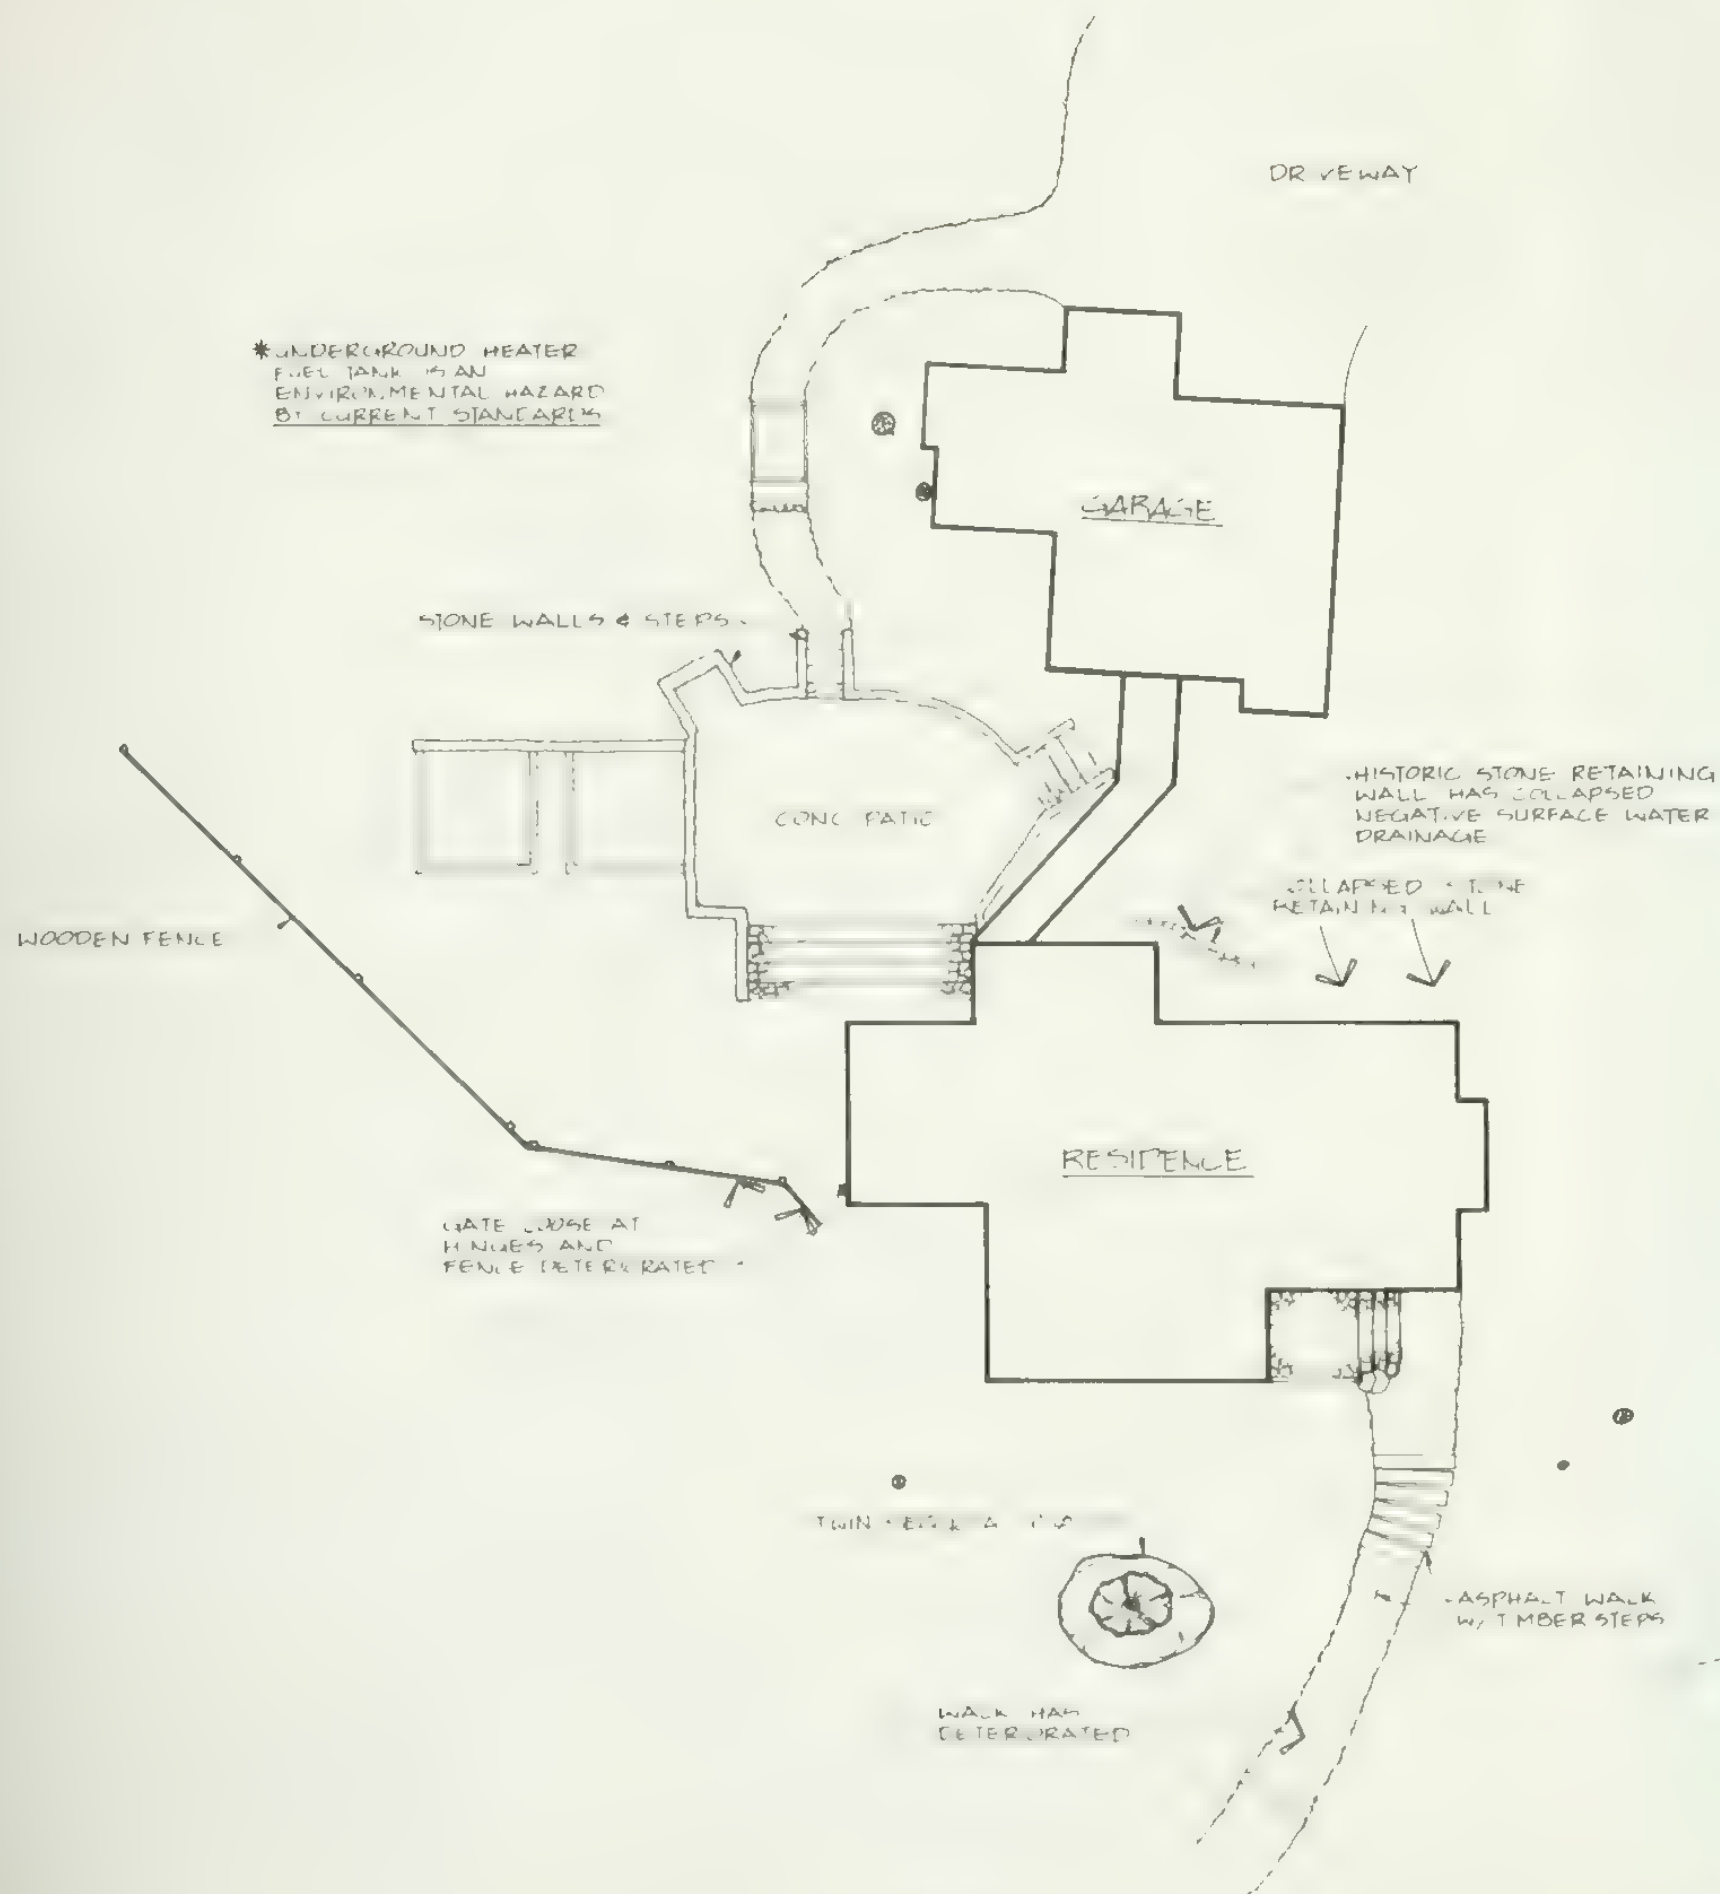
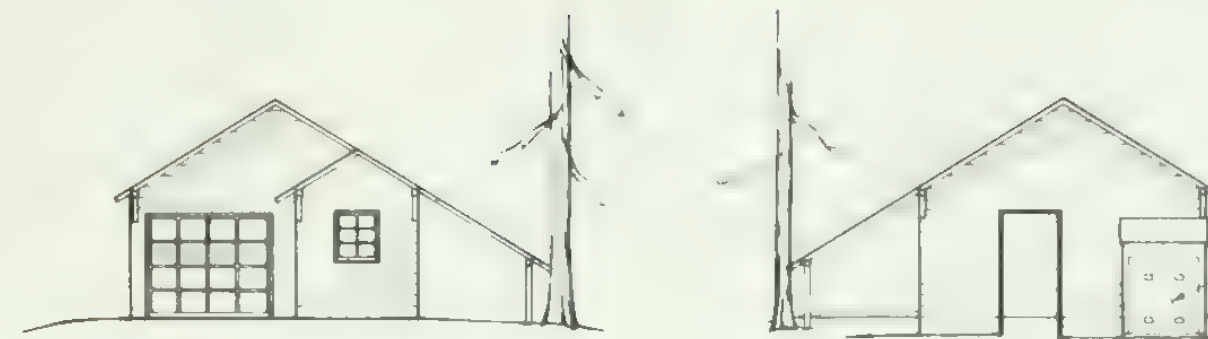
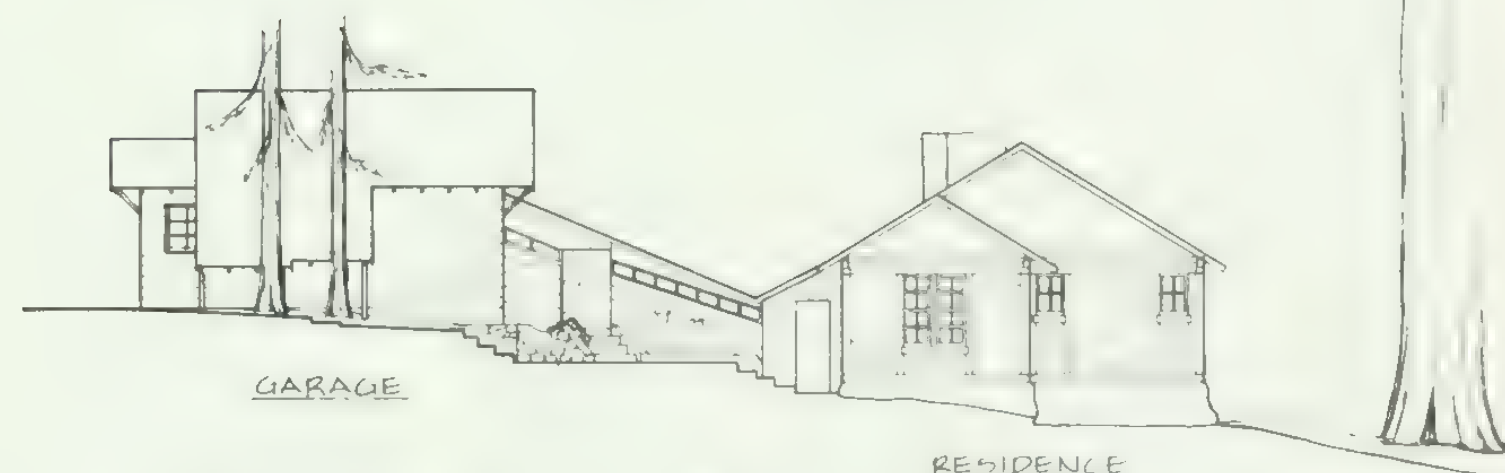
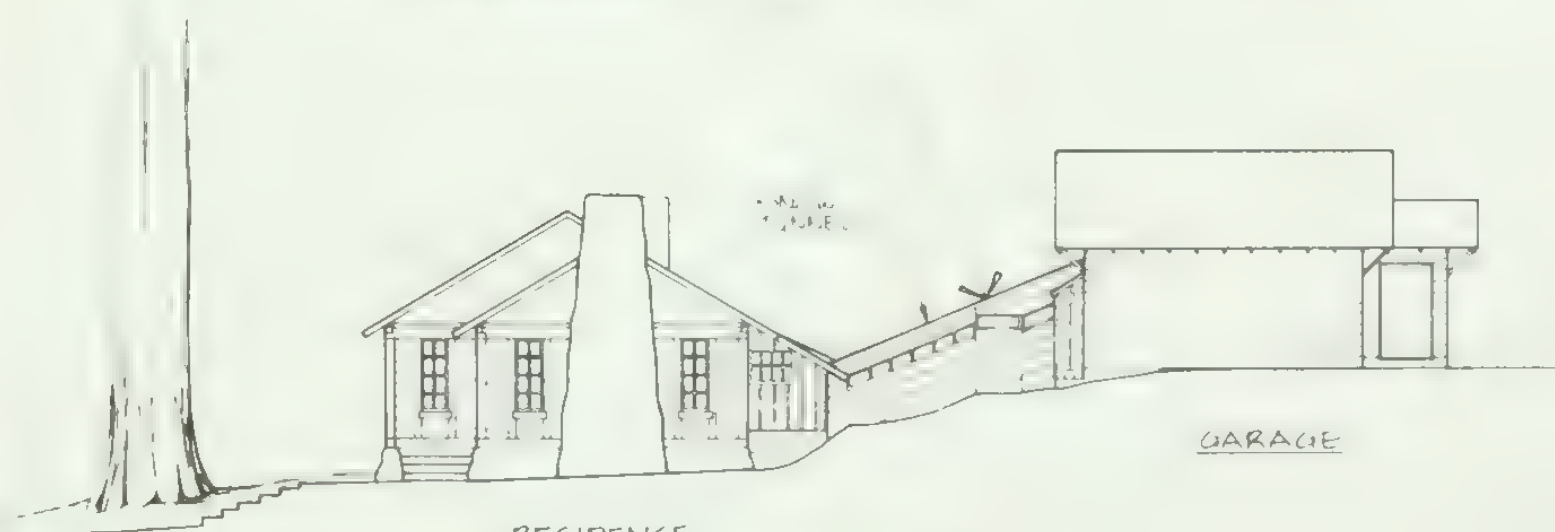
RANGER RESIDENCE/GARAGE  
SITE PLAN, ELEVATIONS  
DEFICIENCIES

\*NO OTHER GARAGE  
DEFICIENCIES ARE  
IDENTIFIED

\*TORN GASH  
STORAGE CABINET

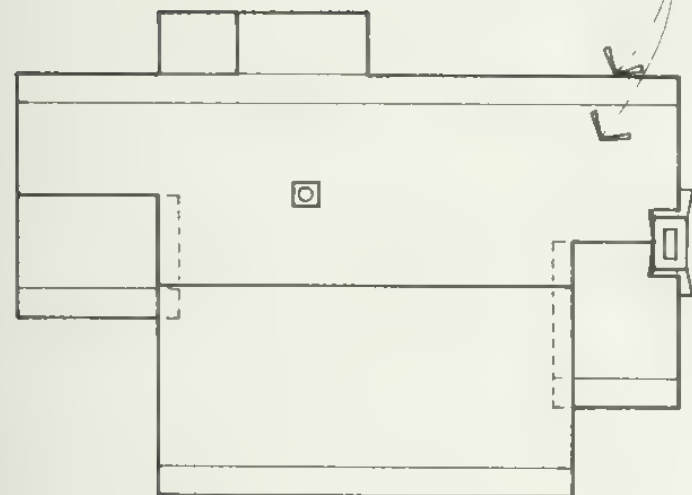
**ROOF**

WOOD SHINGLE ROOF AND SHEET METAL SNOW FLASHING IS AGED AND EXPECTED TO FAIL BY 1991
